Intel[®] Pentium[®] II Xeon[™] Processor Specification Update

Release Date: October 2000

Order Number: 243776-025

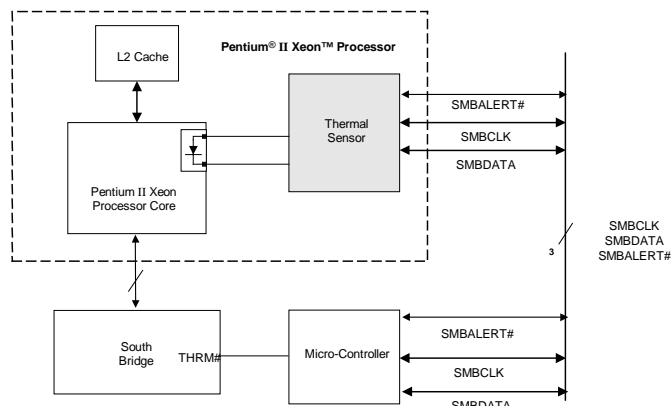
Figure 1. An Example of Microcontroller Driven Thermal Management

D30. Thermal Sensor May Assert SMBALERT# Incorrectly

Problem: The Pentium II Xeon processor has a thermal sensor that monitors the processor core's temperature. The thermal sensor asserts SMBALERT# if the processor temperature exceeds the temperature limits set in the Alarm Threshold Registers (T_{HIGH} , T_{LOW}). It also sets the corresponding Status Register bits to identify the cause of the interrupt. Figure 1 gives one example of the how the SMBALERT# signal could be used in a system.

Under the conditions described below, the thermal sensor incorrectly generates the SMBALERT# interrupt. All of the following conditions must be met to trigger a false interrupt:
